# Preliminary Report

## “PROSPERO”

### No. 0122

## Preliminary report

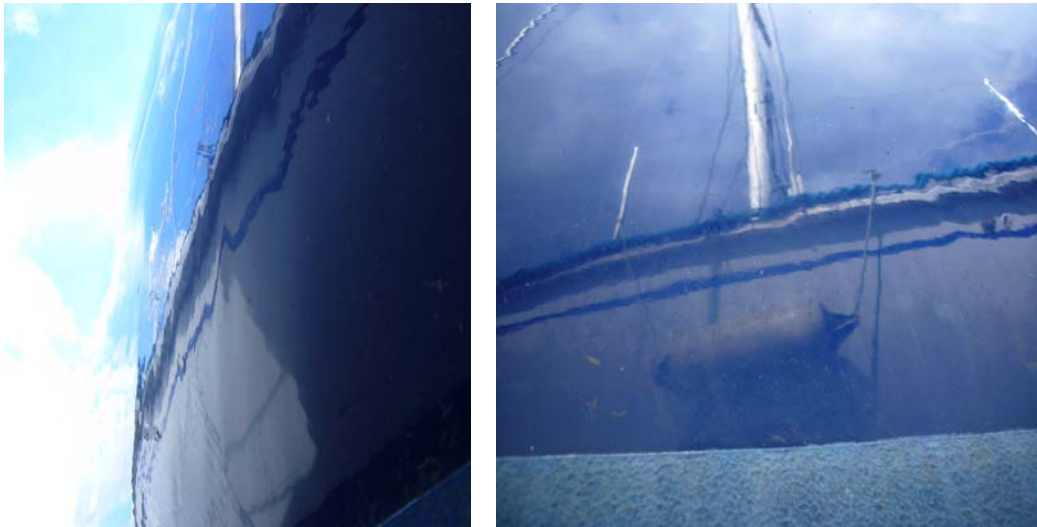
Externally the hull above the waterline has been finished in mid blue gel coat with a white style line. The surface of the hull was visibly irregular. The surface generally was affected by the reinforcement materials of the structural laminate in a pattern commonly known as “print through”. This surface irregularity or print through was extensively visible on both sides.

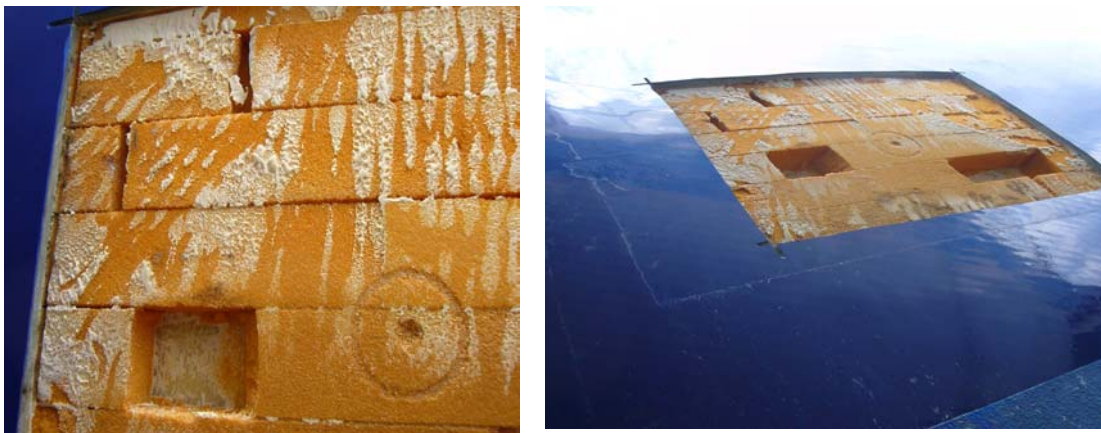
The hull was examined externally where samples had previously been taken. The removed section of GRP outer skin was also examined. This examination revealed non-uniform thickness of the outer skin, irregular application of the skin to core bonding material and a very poor quality of core installation. Examination of the hull in way of the boundary of the sample areas clearly showed a total lack of bond between the outer surface of the core and the inner surface of the outer skin. Tap testing of the shell above the waterline indicated that the outer skin was not bonded or had become de-bonded from the core over the majority of the shell surface both port and starboard. Tap testing of the hull below the waterline did not reveal any significant defects.

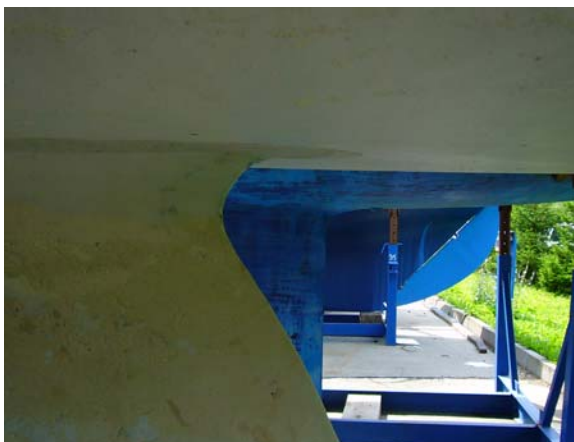
Inspection of the hull profile below the waterline indicated the presence of a concave area aft of the keel, symmetrically about the centre line. A 55mm diameter sample was removed from the hull below the waterline on the port side forward of the mast. The sample location was selected to be within the highest stressed part of the hull structure but accessible from both sides for ease of repair.

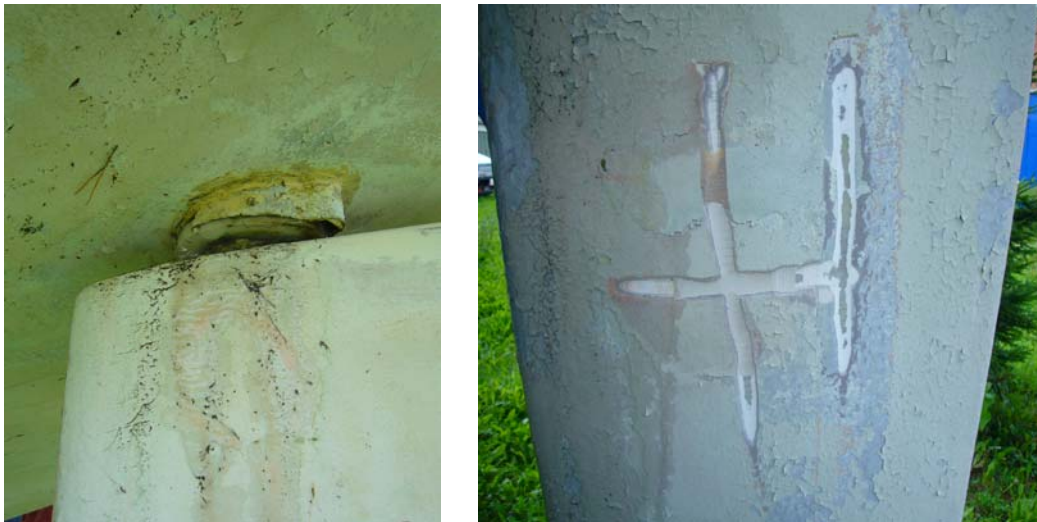
The rudder was examined and tap tested. The surface coatings were then removed by abrasion and the structure examined again. The rudder appears to be constructed of two GRP skins bonded together at the centreline. There is evidence of a substantial repair in the centre of the blade. During the course of my inspection water was seen to be emanating from the joint between the hull shell and the rudder trunk. The passage of water was continuous suggesting the presence of a reservoir or at least 10 litres capacity. The inside of the hull was examined in way of the rudder trunk but the location of the reservoir could not readily be established.

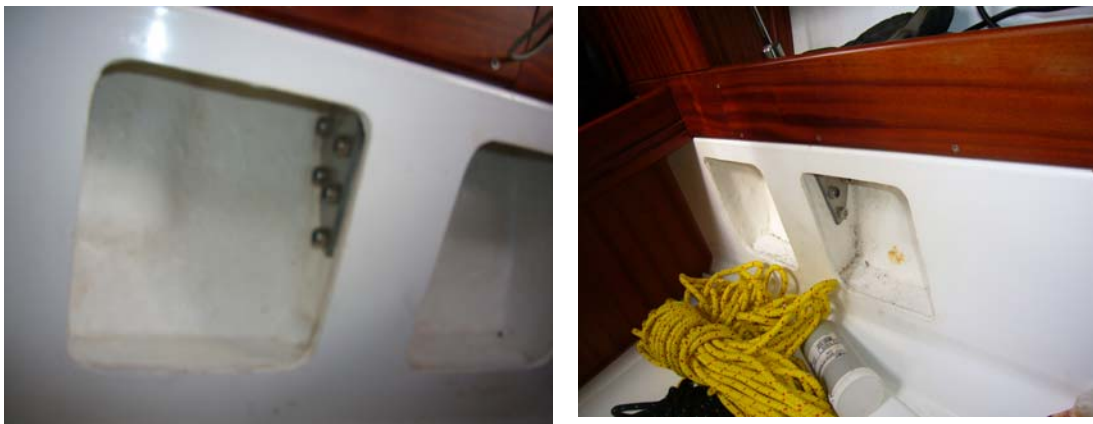
The support structures for the chain plates were examined port and starboard. These structures consist of stainless steel plates bolted to a laminate that is bonded to the inside of the shell and the outside of the GRP interior module. The adjustable tie rods supporting the chain plates on deck are pin linked to these plates. There is no evidence of significant disturbance of these structures.

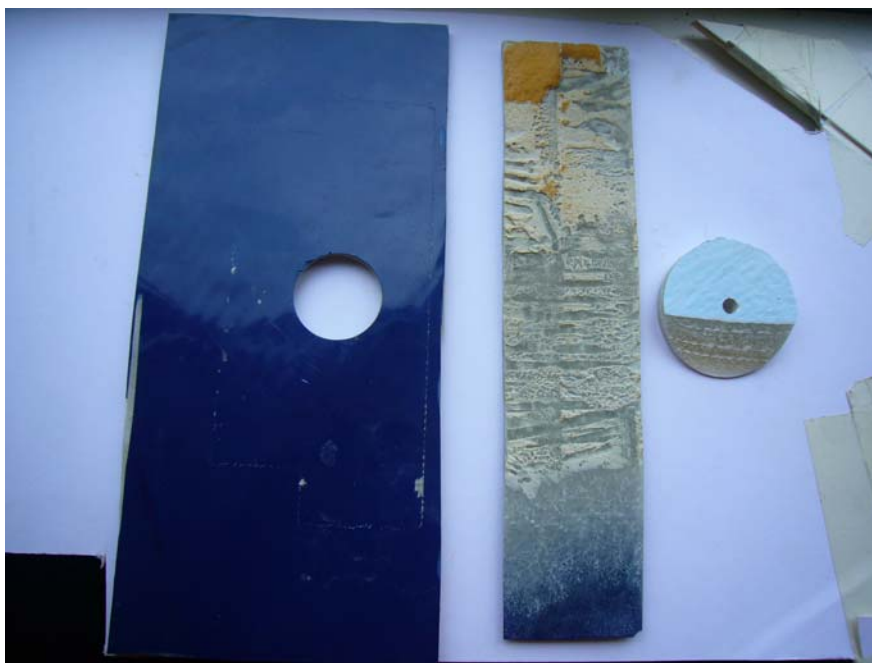
Three shell samples were retained for detailed examination. These were the two samples previously removed from the outer skin on the starboard side and the monolithic shell sample taken below DWL on the port side. These have been designated as sample 1, sample 2 and sample 3. Sample 1 measures 270mm x 125mm with a 35mm diameter hole and was taken from the upper part of the sample area approximately midway up the topsides of the hull. Sample 2 measures 250mm x 55mm and represents the balance of the sample area. Sample 3 from below DWL measures 55mm diameter. The three samples were subjected to detailed examination for construction quality and specification.

Location	Dimensions	Quality	Laminations
Sample 1	270 x 125	Good	CSM 220 g/m <sup>2</sup>
Mid topside	Min 3.6mm	Good	CSM 300 g/m <sup>2</sup>
	Max 5.7mm	Good	WR 450 g/m <sup>2</sup>
		Fair	CSM 450 g/m <sup>2</sup>
		Poor	Bonding paste

Location	Dimensions	Quality	Laminations
Sample 2	250 x 55	Good	CSM 300 g/m <sup>2</sup>
Lower topside	Min 3.4mm	Good	WR 450 g/m <sup>2</sup>
	Max 4.6mm	Good	CSM 450 g/m <sup>2</sup>
		Poor	Bonding paste
Sample 3	55mm Ø	Good	CSM 220 g/m <sup>2</sup>
Below DWL	Min 9.2mm	Good	CSM 300 g/m <sup>2</sup>
	Max 10.1mm	Good	WR 450 g/m <sup>2</sup>
		Good	CSM 450 g/m <sup>2</sup>
		Good	WR 450 g/m <sup>2</sup>
		Good	CSM 300 g/m <sup>2</sup>
		Good	CSM 300 g/m <sup>2</sup>
		Good	WR 450 g/m <sup>2</sup>
		Good	CSM 450 g/m <sup>2</sup>
		Good	Flowcoat
